Portage Creek Sediment Remediation Project Kalamazoo, Michigan

Pre-Sediment Removal Structure Feature Assessment
Removal Areas SA5-Axtell, SA5-D and SA5-C

F&V Project Number: 809930
May, 2012

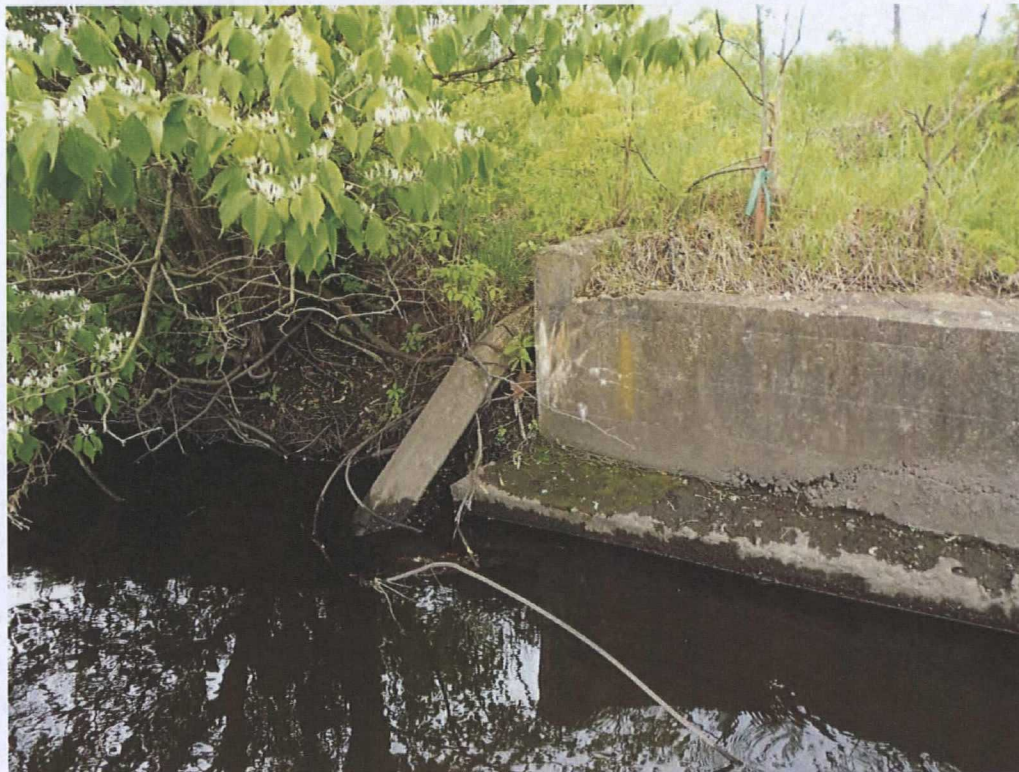
- Severe bank erosion was noted around the northeast, southeast and northwest and minor erosion in the southwest, however no undermining was detected.
- A severely spalled concrete post remains in the northeast and there is a failed concrete post on the southwest slope area.
- The concrete is in fair condition with shallow spalling and scaling as well as scattered cracking noted.

Failed concrete post in the southwest

- Because the structure has been abandoned, it can likely be removed. However, it is recommended that the City of Kalamazoo be consulted to verify as it may be feasible to salvage the abutments for a future crossing at this location.

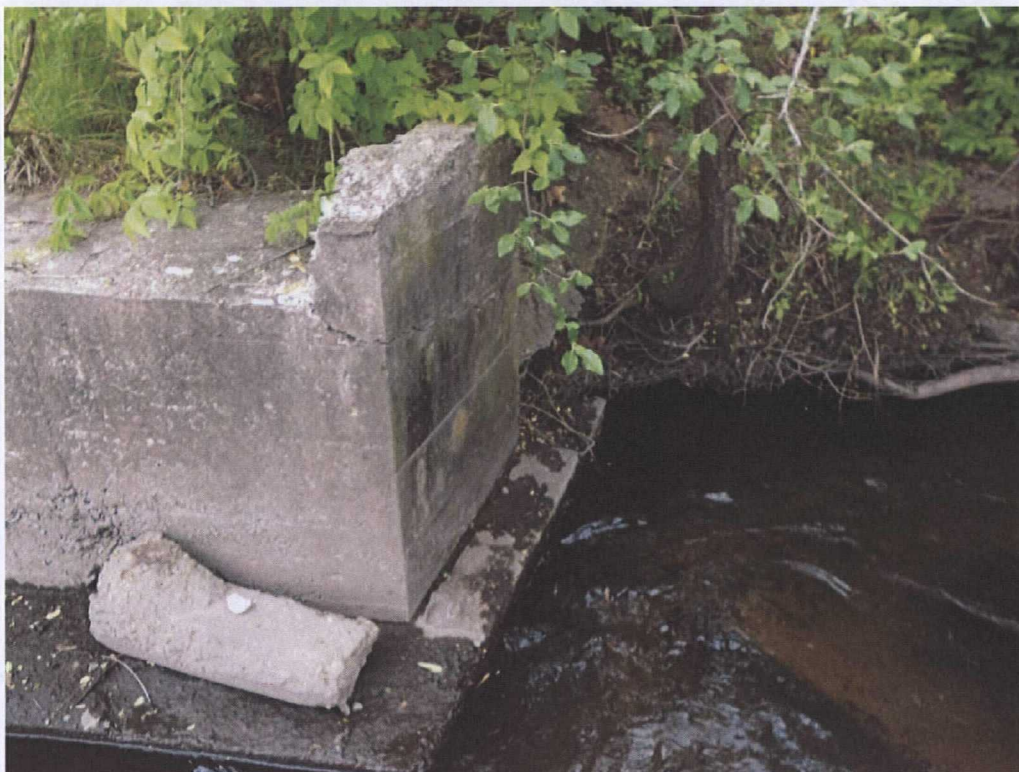
Severe bank erosion in the northwest

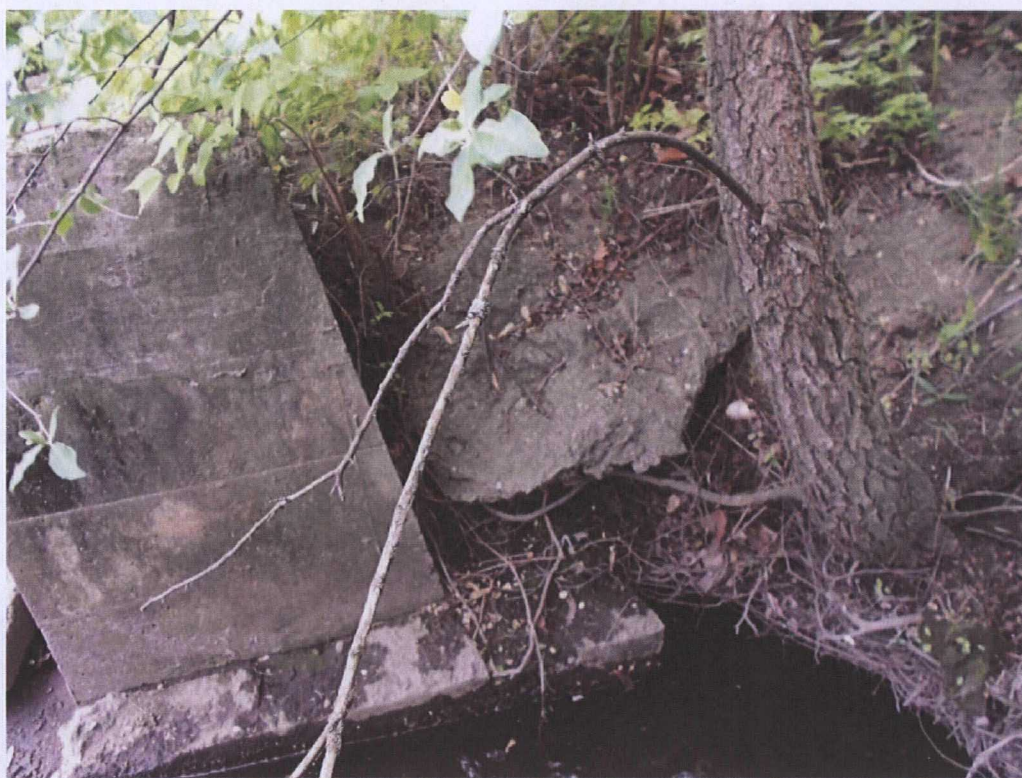
Severe erosion behind the northwest abutment

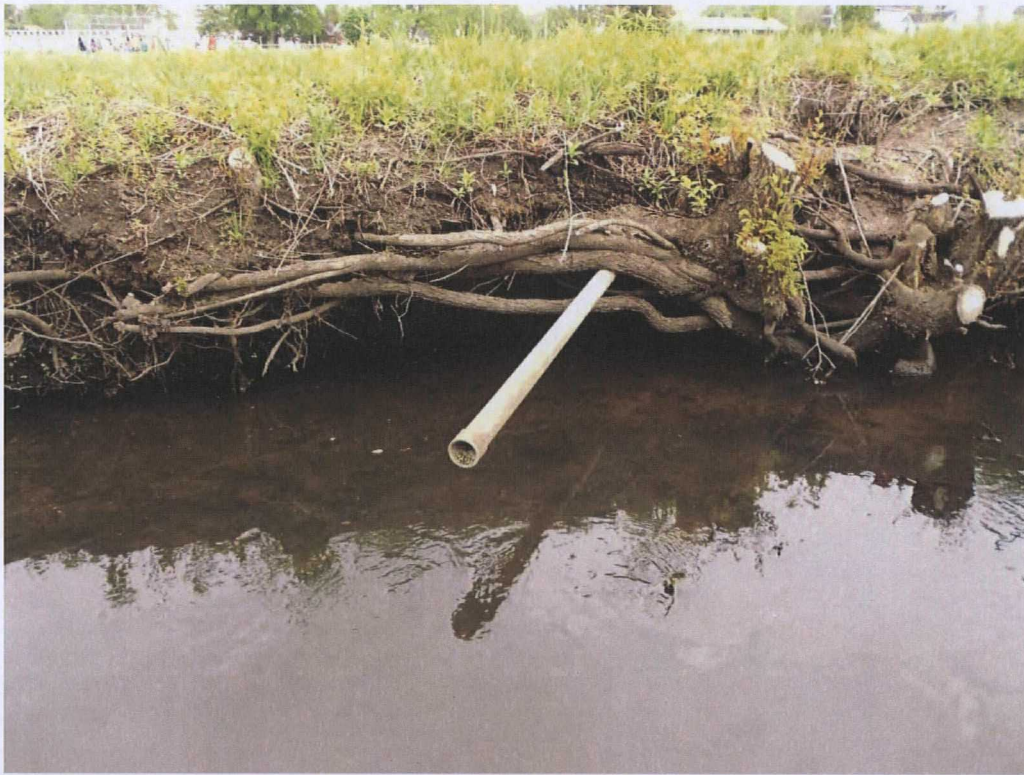
- Severe bank erosion appears to have caused the conduit's extension into the channel. The bank is severely undercut in the area.
- The conduit is plugged with debris and appears to be abandoned.

View of the structure from the channel with severe root growth and bank undercutting

- Because the structure appears to be abandoned, it can likely be cut off and plugged at the bank to allow for sediment removal.

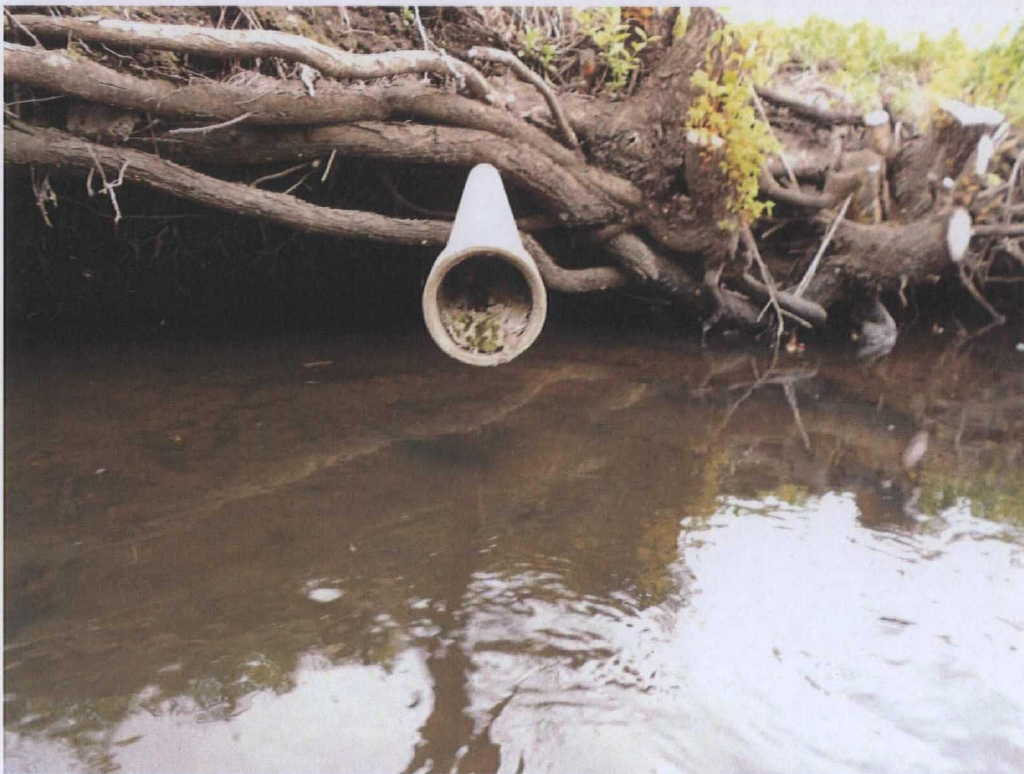
Close-up of the end of the conduit plugged with debris

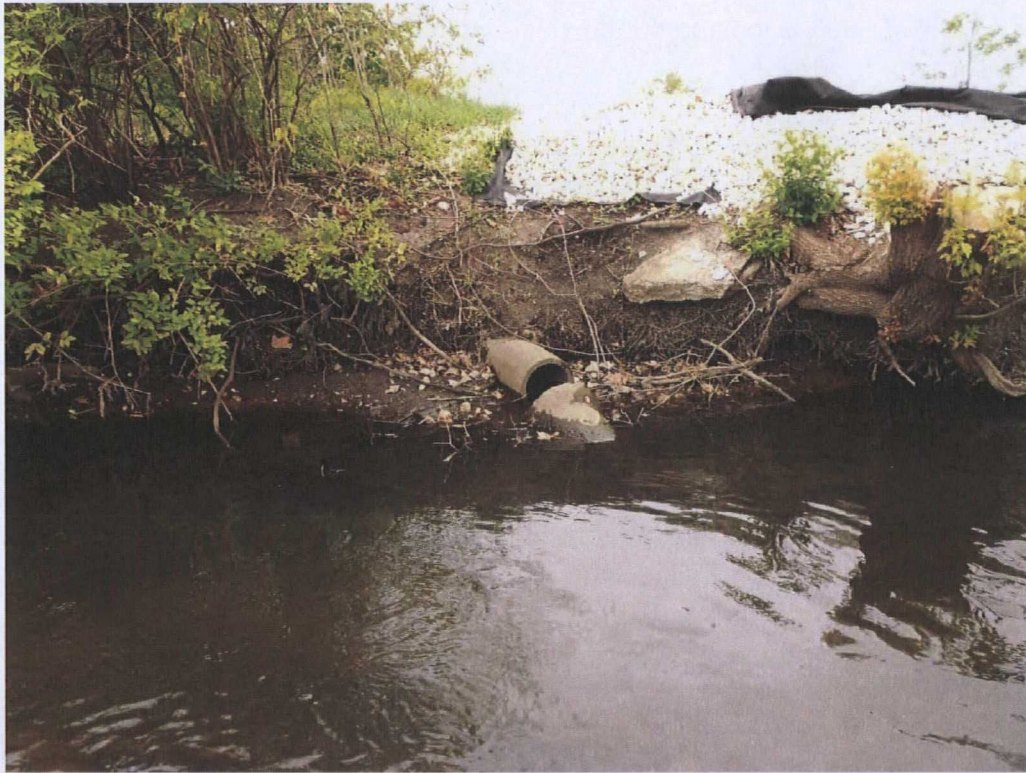
- The end section of pipe has failed from severe bank erosion and the second section is exposed ~18-24".

View of the structure from the channel

- Remove the failed end section and install an isolation cofferdam with approximately 2' clearance. Because the outlet appears to be from previous development and not active, it may be possible to eliminate the isolation cofferdam and use caution to avoid undermining the structure.

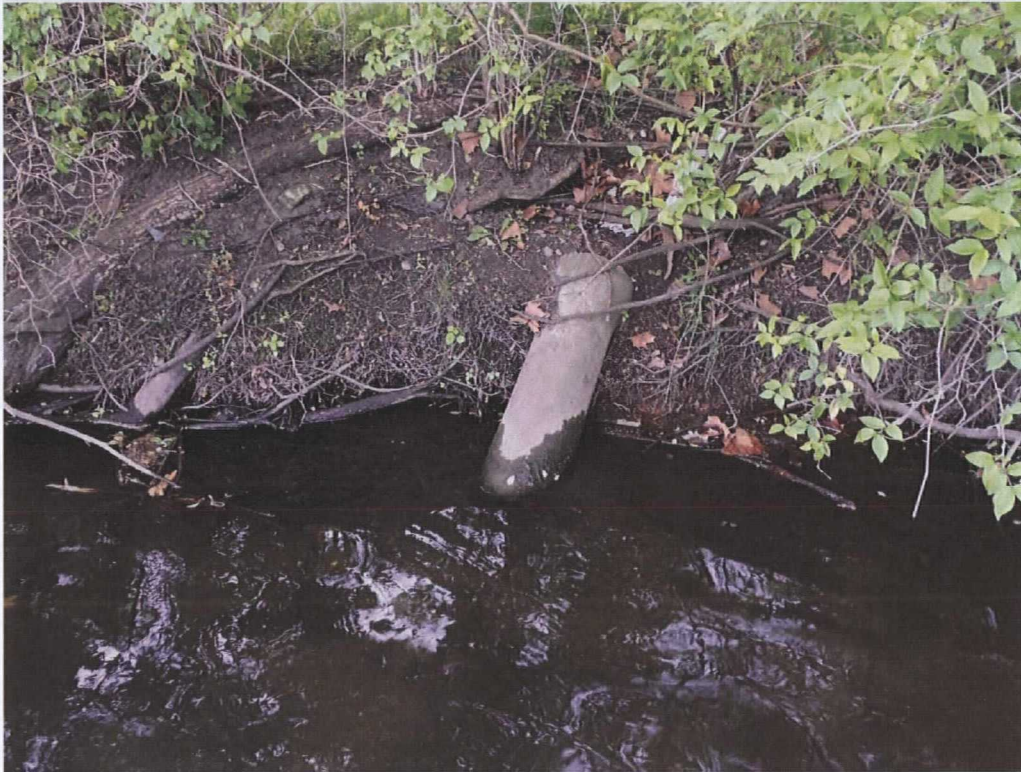
- The end section of pipe has failed from severe bank erosion.
- The outlet does not appear to be active.

View of the structure from the channel

- Remove the failed end section. Because the outlet does not appear to be active, an isolation cofferdam is likely not required. The outlet is located far enough above the waterline in the bank that undermining is not a significant concern.

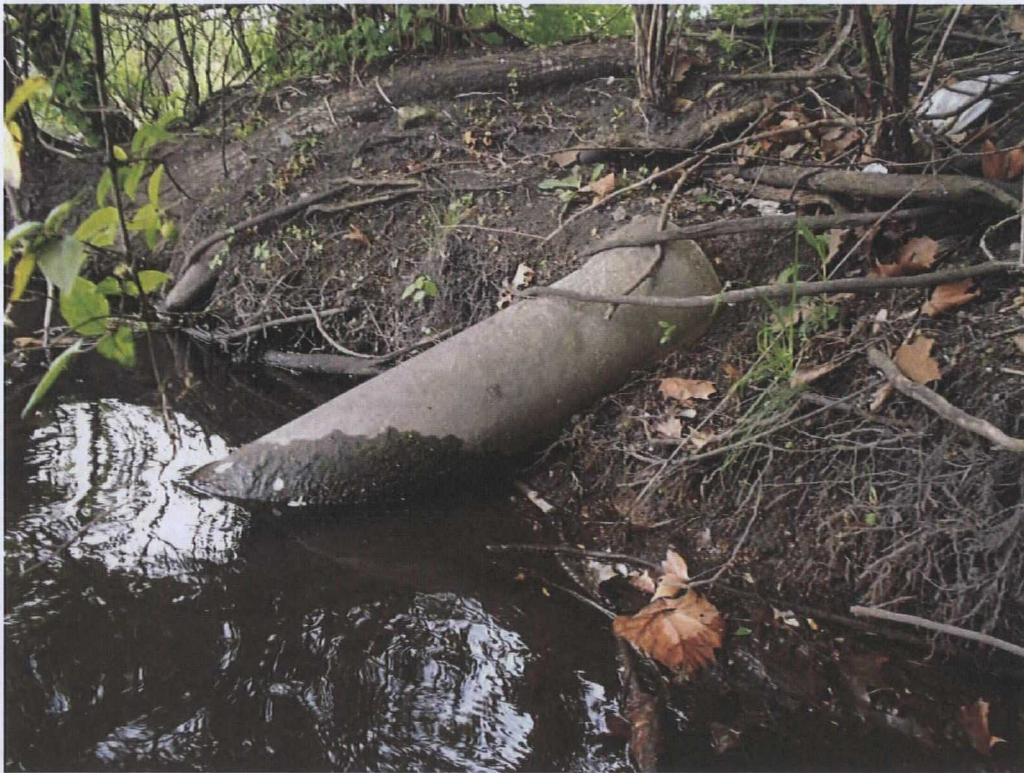
View of the structure from the downstream channel

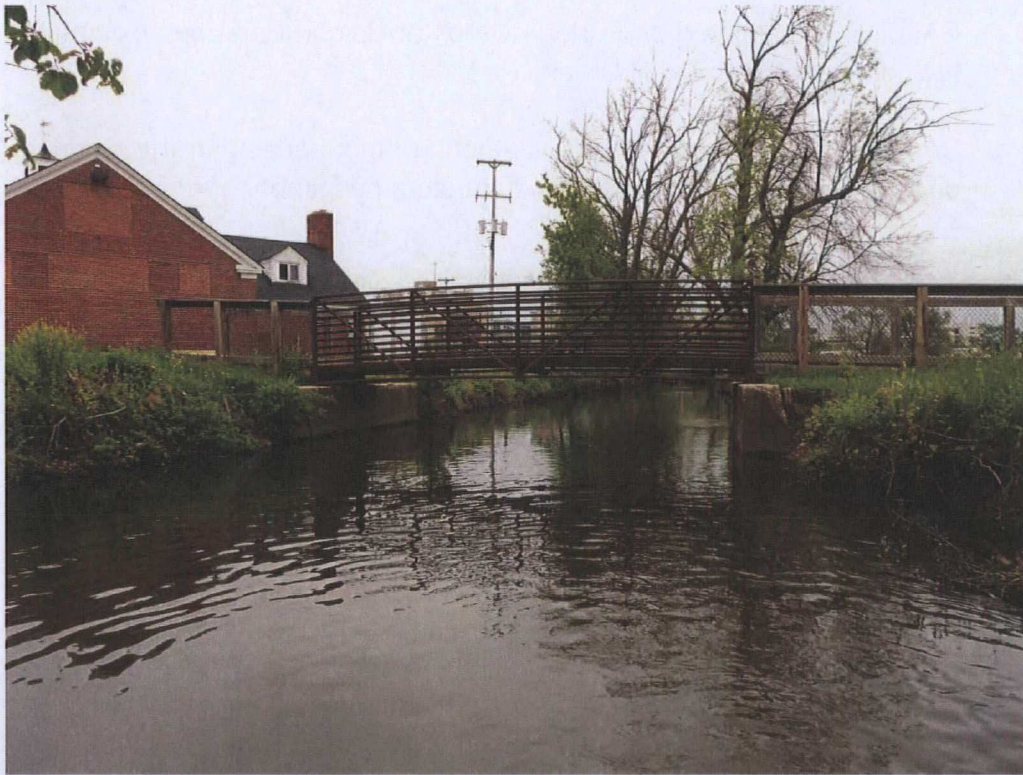
- Moderate bank erosion was noted around the southeast abutment. Roots from large stumps are holding the west banks.
- The top corners of the abutments are spalled throughout.
- The channel bottom is approximately 5' below the bottom chord of the truss. Logs and trash were noted in the northeast channel.
- The truss is weathering steel and has developed its patina, but minor pitting was noted.
- The timber decking has moderate weathering and splitting of planks throughout.

Elevation view of the structure from the upstream channel

- Construction records are not available for this structure, however it is suspected that the abutments are supported on spread footings several feet below the current channel bottom. We understand that the steel truss is to be temporarily removed to accommodate sediment removal. In this case, a cofferdam is recommended around each abutment to protect them from undermining. Because of the suspected depth of footing, it may be possible to begin sediment removal without cofferdams and install them only if the sediment removal is required below the bottom of footing elevation.
- If the truss is not removed, a simple isolation cofferdam across the channel is recommended upstream and downstream a minimum of 2' clear of the abutments.

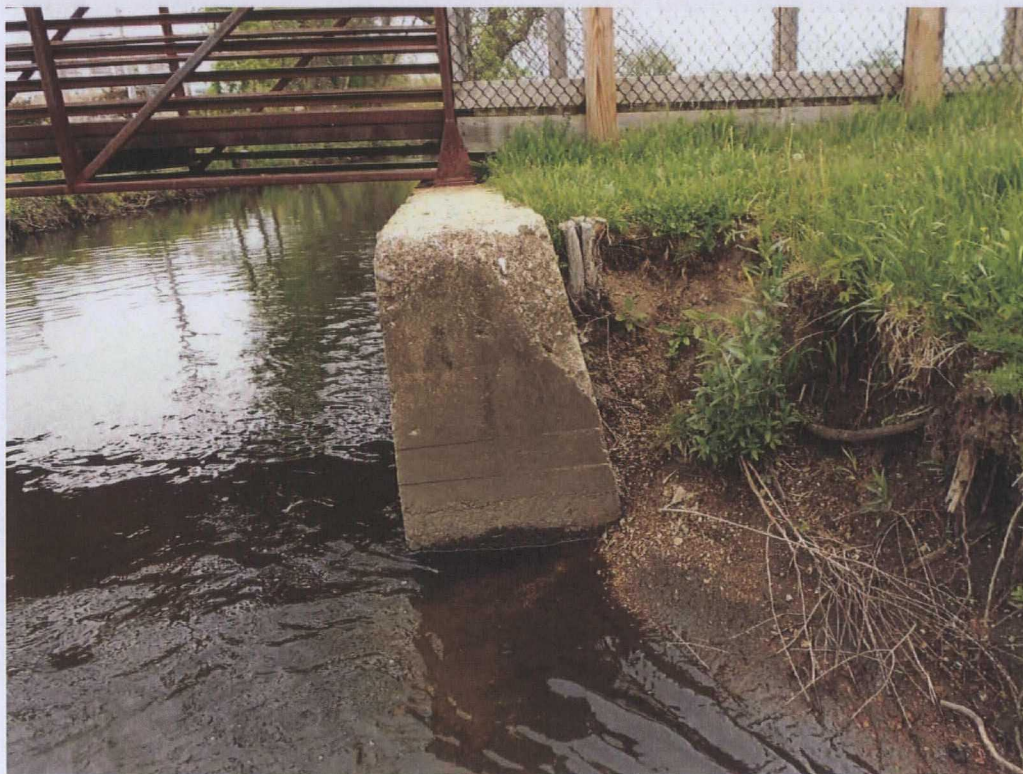
Bank erosion in the southeast

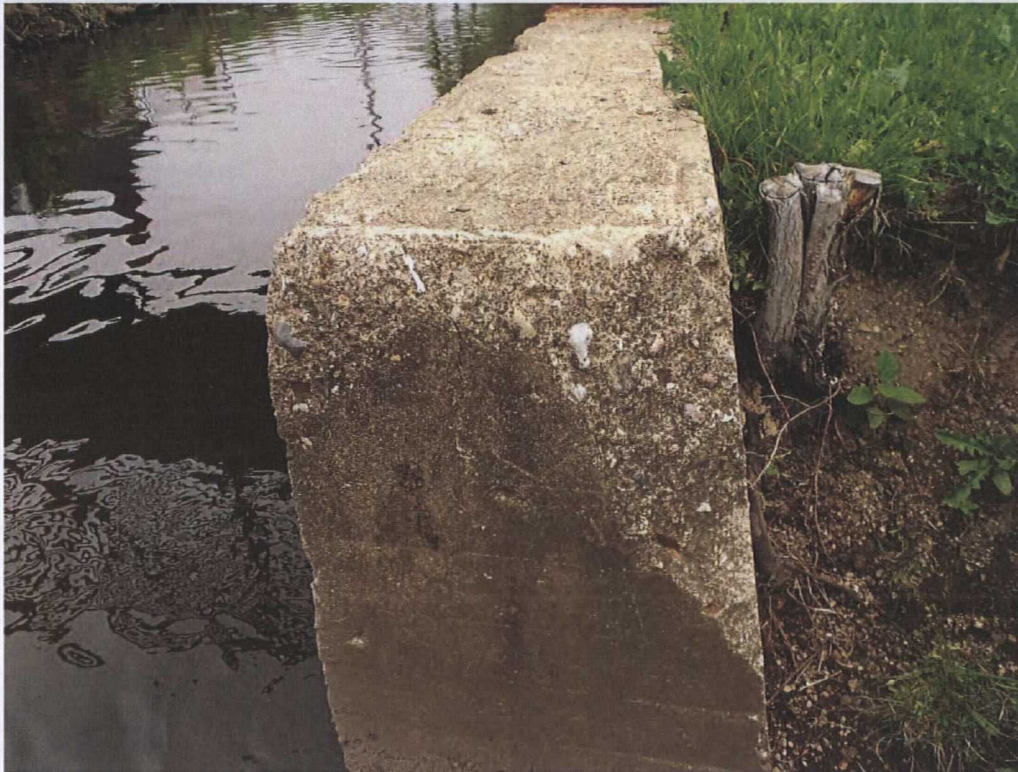
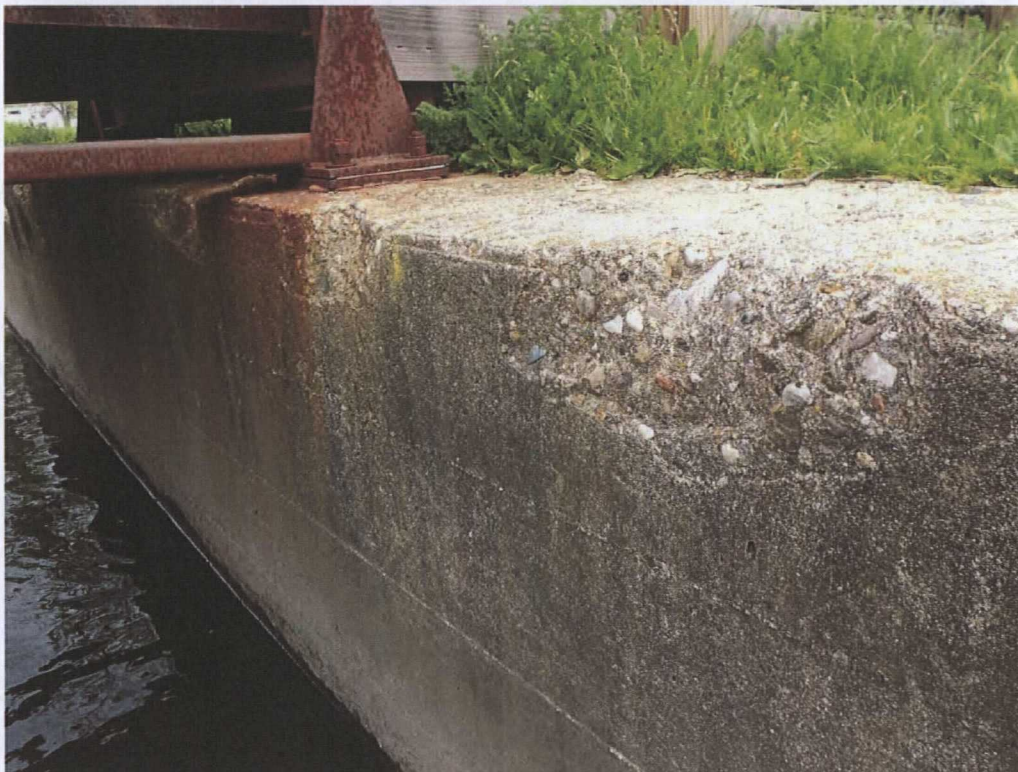
Spalling on the southeast abutment

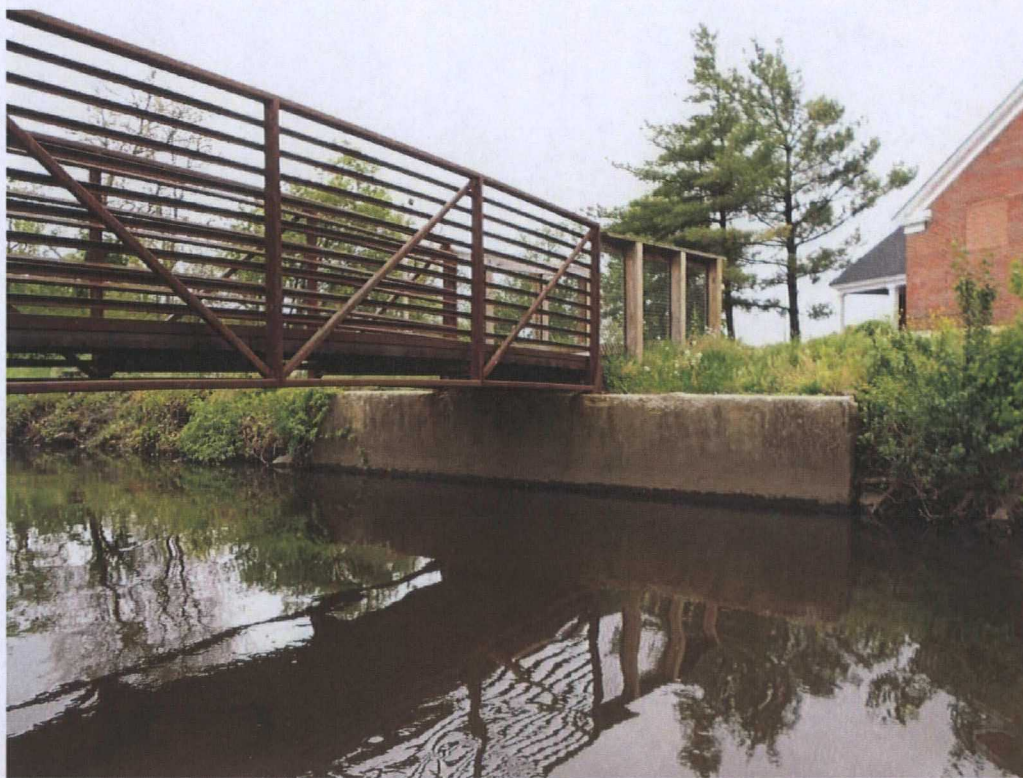
Overall view of the west abutment

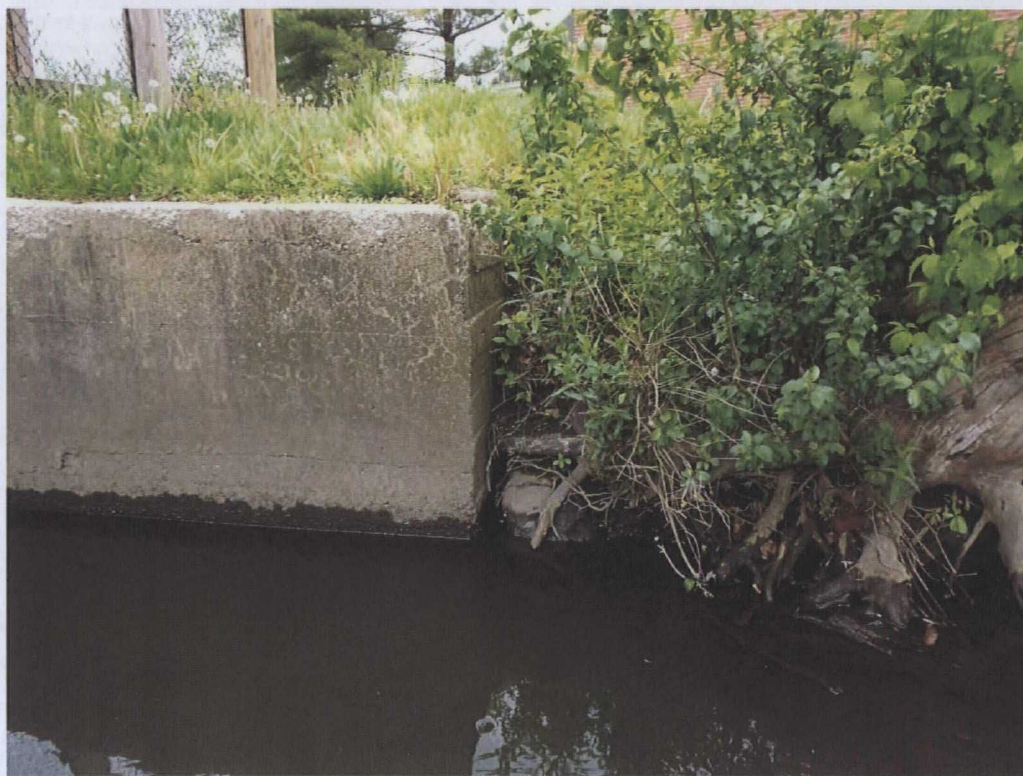
Northwest bank stabilized by roots

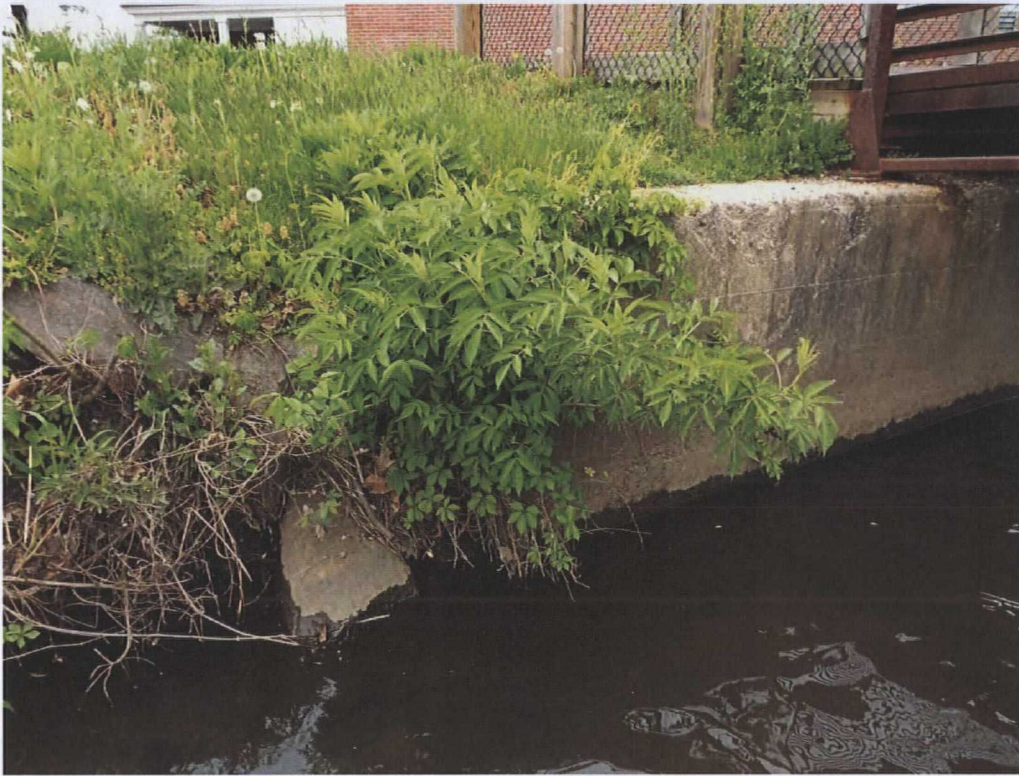
Southwest bank stabilized by roots

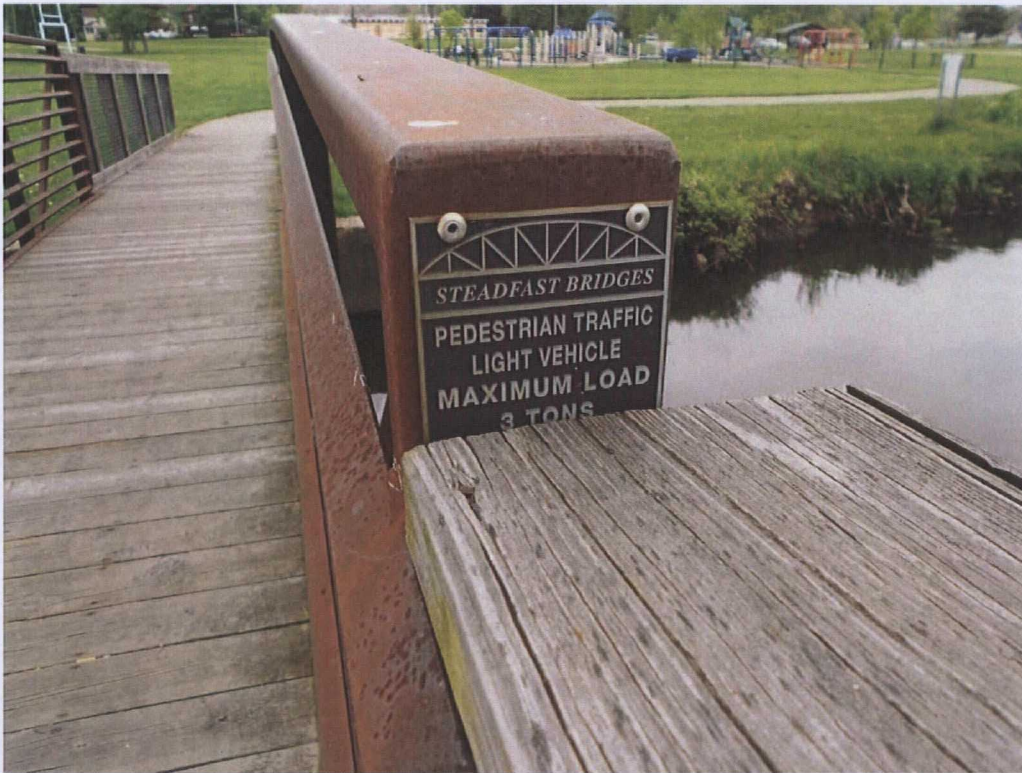
Bridge plate obscured by approach railing

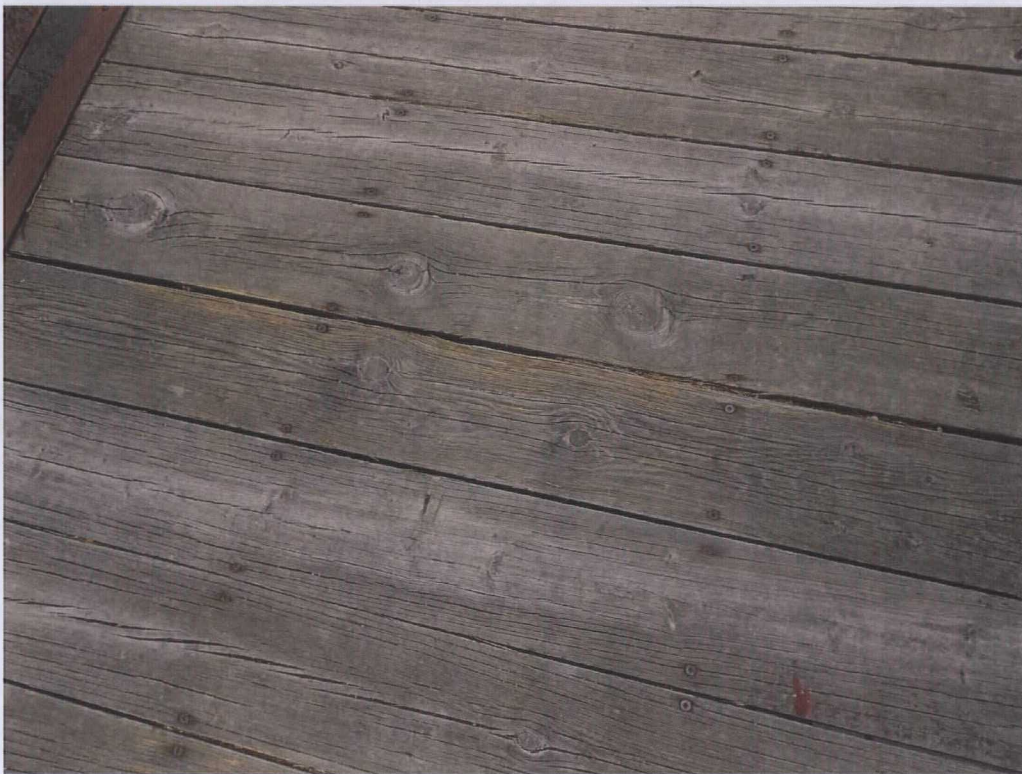
Weathering and splitting of timber deck planks

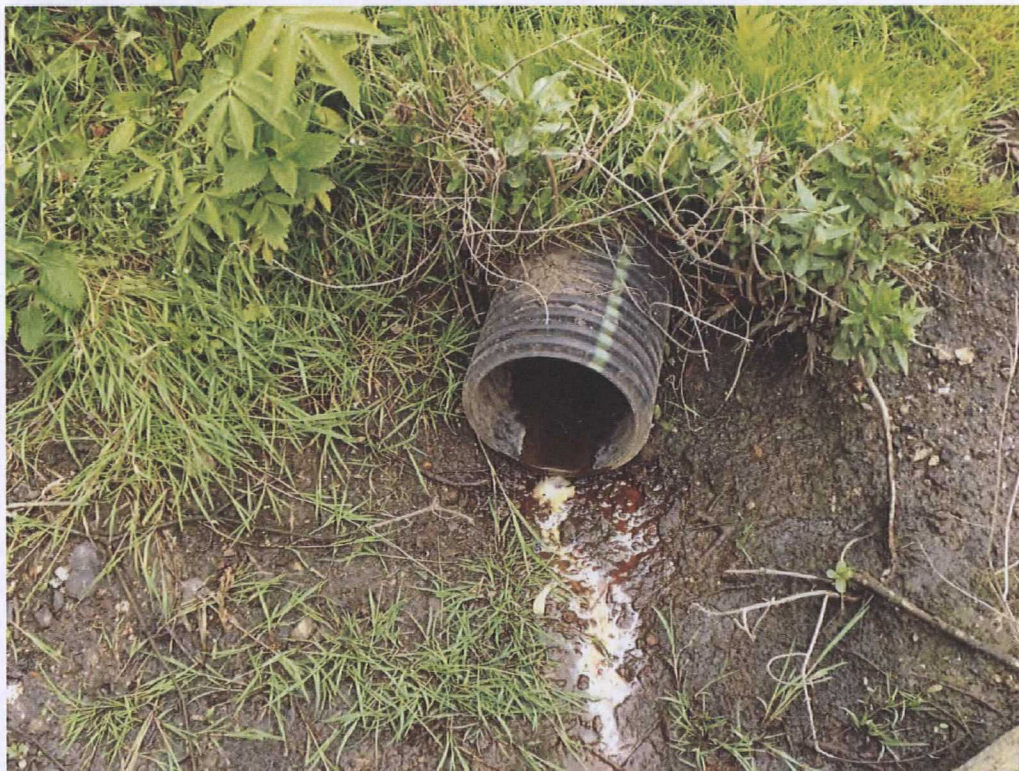
- Moderate bank erosion has exposed ~12-18" of the pipe, however, the pipe is set back approximately 2' from the water's edge in an area where the bank is low.
- The pipe appears to be in good condition with no significant deterioration noted.
- The outlet is slightly undermined.

Small flow of water from outlet

- Because the structure is set back from the water's edge, further undermining is not a significant concern. However, undermining should be repaired if it does occur.
- At the time of evaluation, the outlet had a small flow of water and an isolation cofferdam is recommended for dewatering.

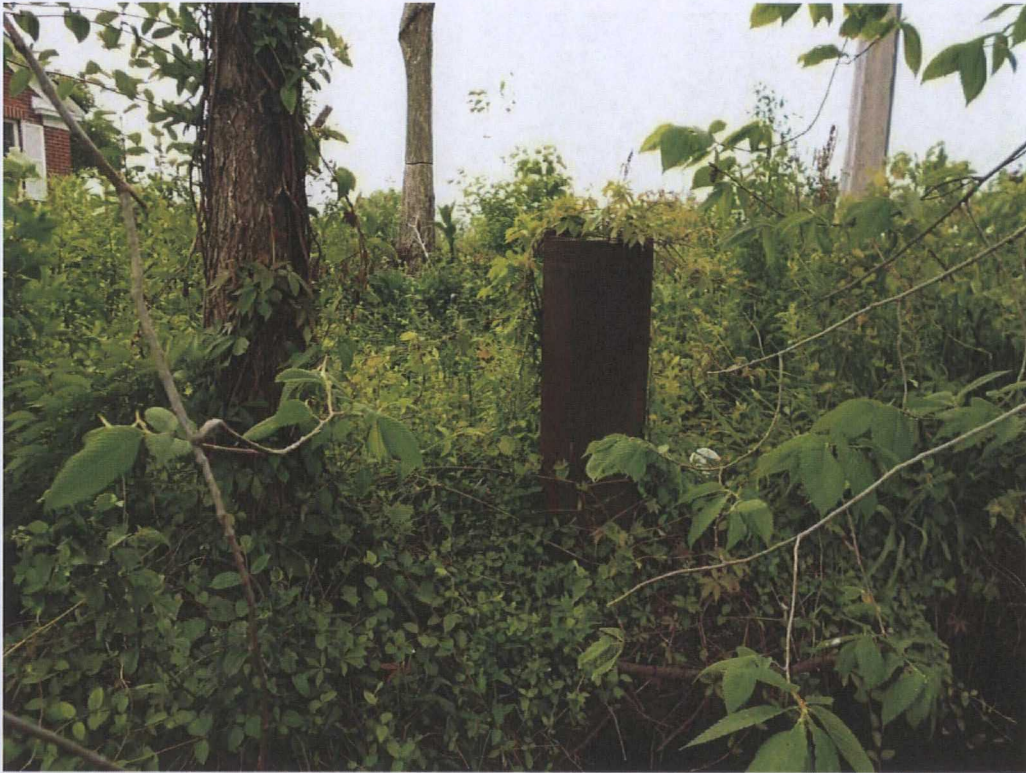
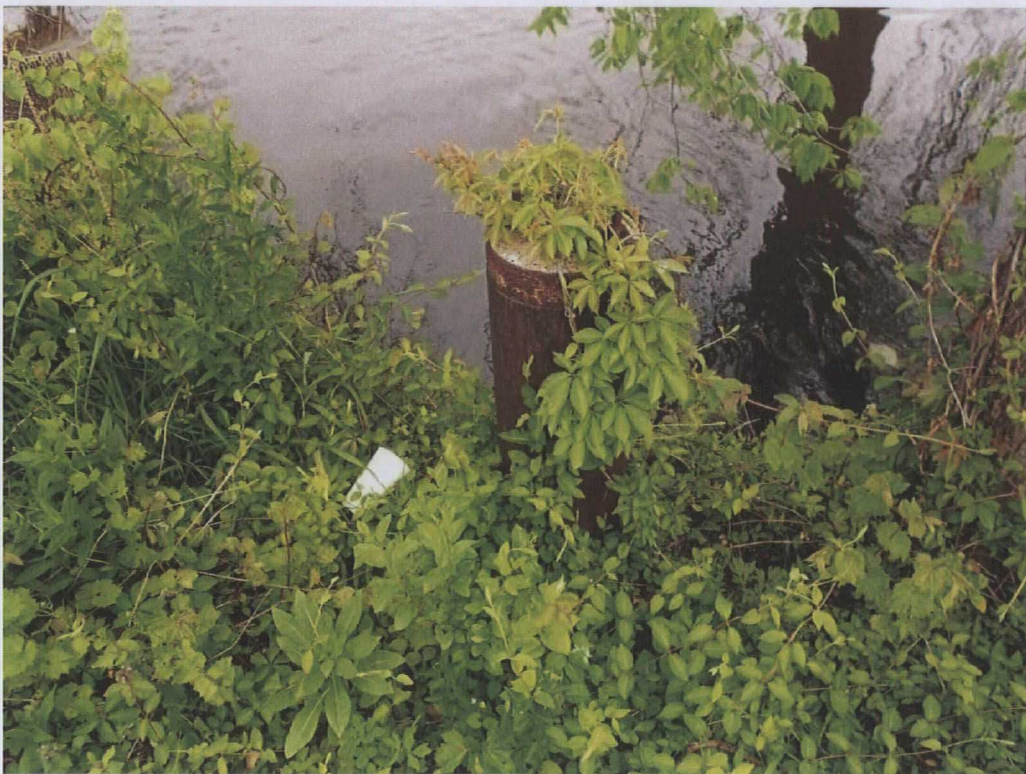
- Both bollards have minor surface corrosion and are overgrown with vegetation.
- The east bollard is set back approximately 4' from the water's edge behind a large tree. The west is located approximately 1' from the water's edge.

View of west bollard from channel

View of west bollard from bank

- The bollards and conduit should be protected from damage during excavation operations by installing construction fencing or other means to make operators and drivers aware of their location.
- The west bollard can likely be removed if it conflicts with excavation operations, however the east one should be avoided to prevent impacting the suspected abandoned gas main.

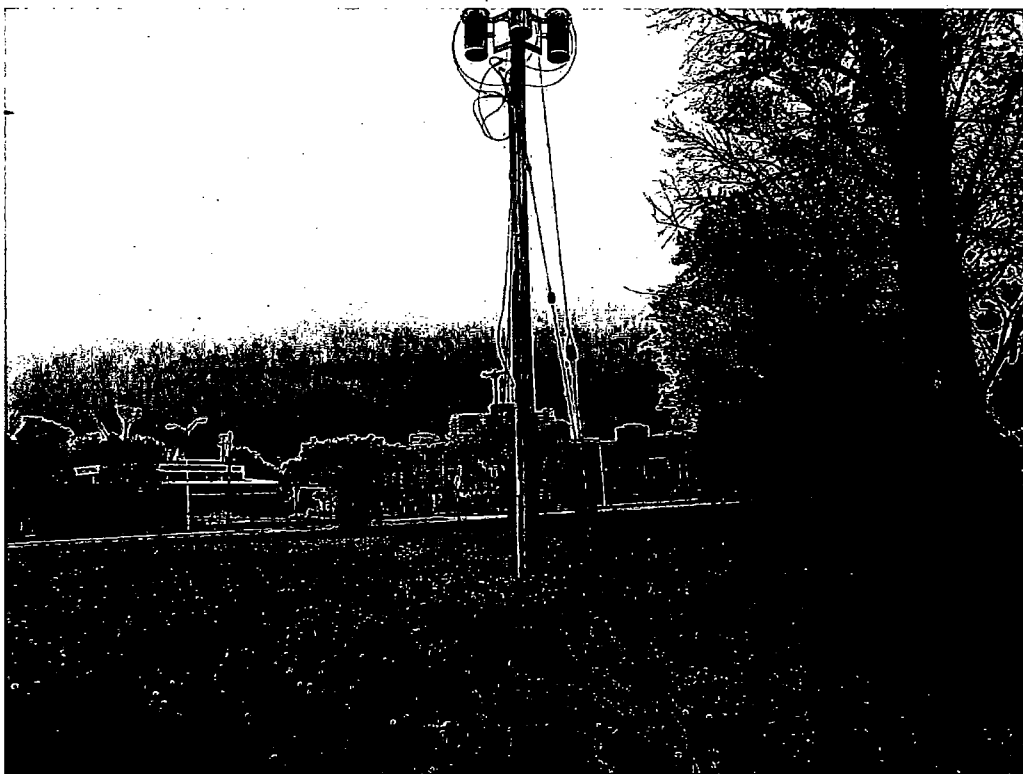
View of pole and guy looking north

Overall view of the overhead electric facility

- Because of their distance from the excavation area, the pole and guy will not be impacted by the excavation itself, however, they should be protected with construction fence or similar to make operators and drivers aware of their location.

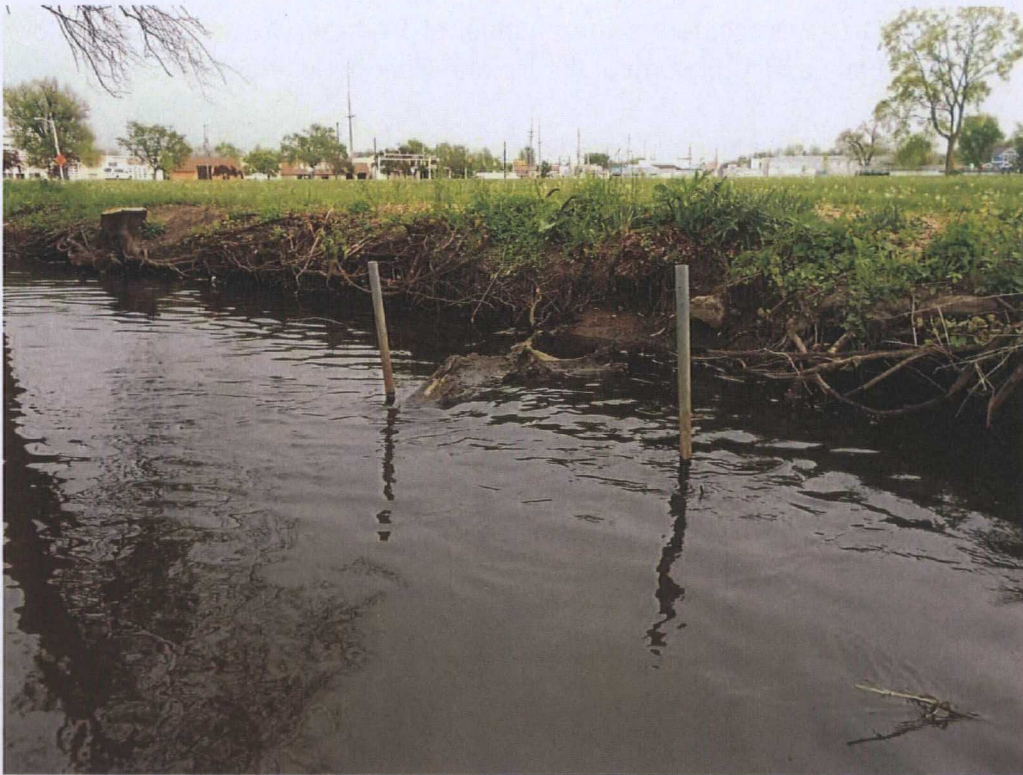
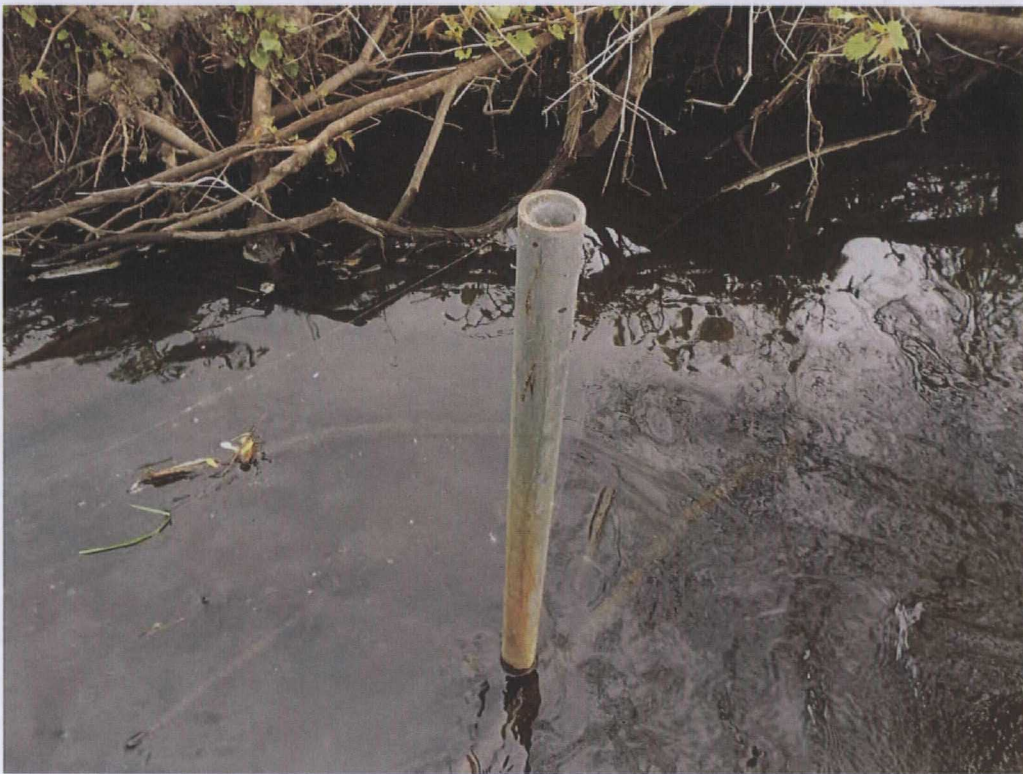
- There appears to be additional pier debris in the channel around the pipes.
- The steel pipes are leaning slightly and have signs of early corrosion near the waterline.

View of the structure from the upstream channel

Close-up of steel pipe

- Remove the pipes and other pier debris in conjunction with excavation work.

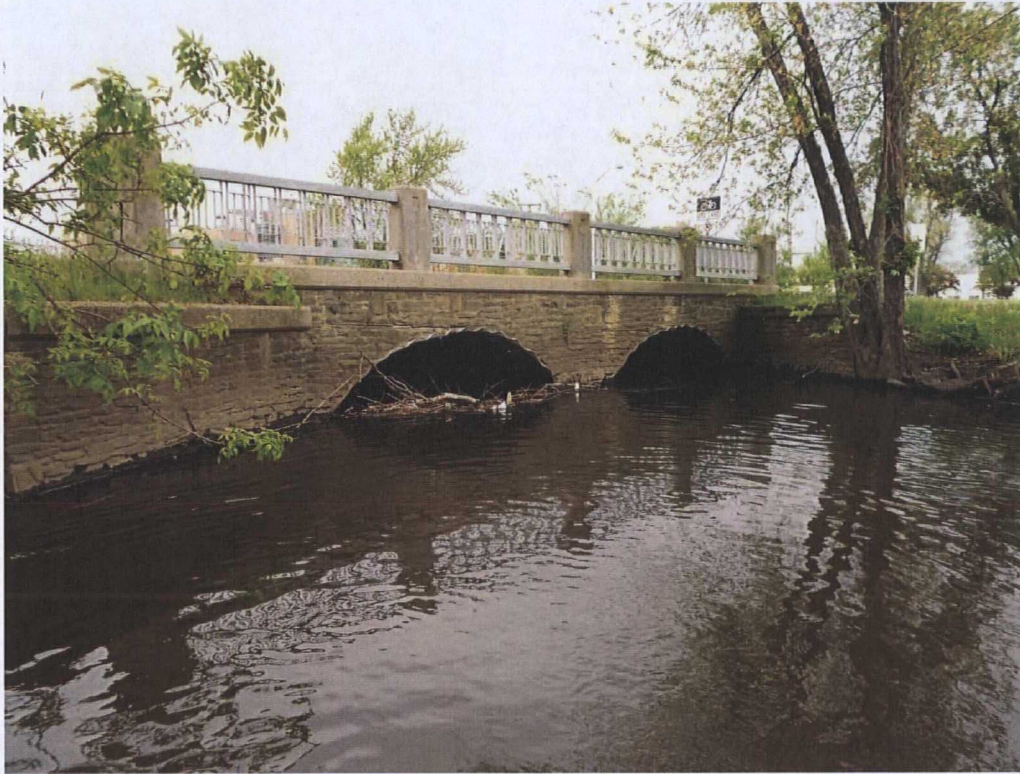
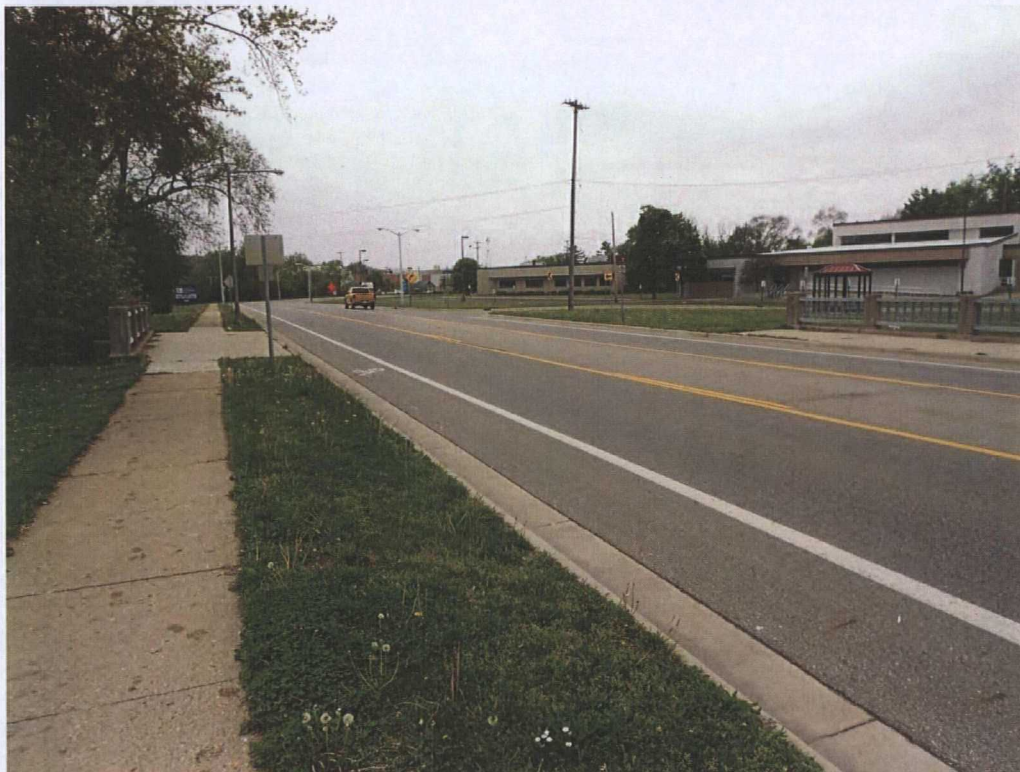
Elevation view of the structure from the upstream channel

View of the structure from the southeast approach area

- The wingwalls and headwalls are masonry-type construction with various degrees of cracking and are more susceptible to damage from vibration than concrete. Therefore it is recommended that the cofferdams at the Crosstown Parkway bridge be constructed of sand bag walls, placed with approximately 4' clearance from the walls.
- The unidentified steel cover in the northwest should be excavated and opened prior to cofferdam installation to check for a possible utility crossing.

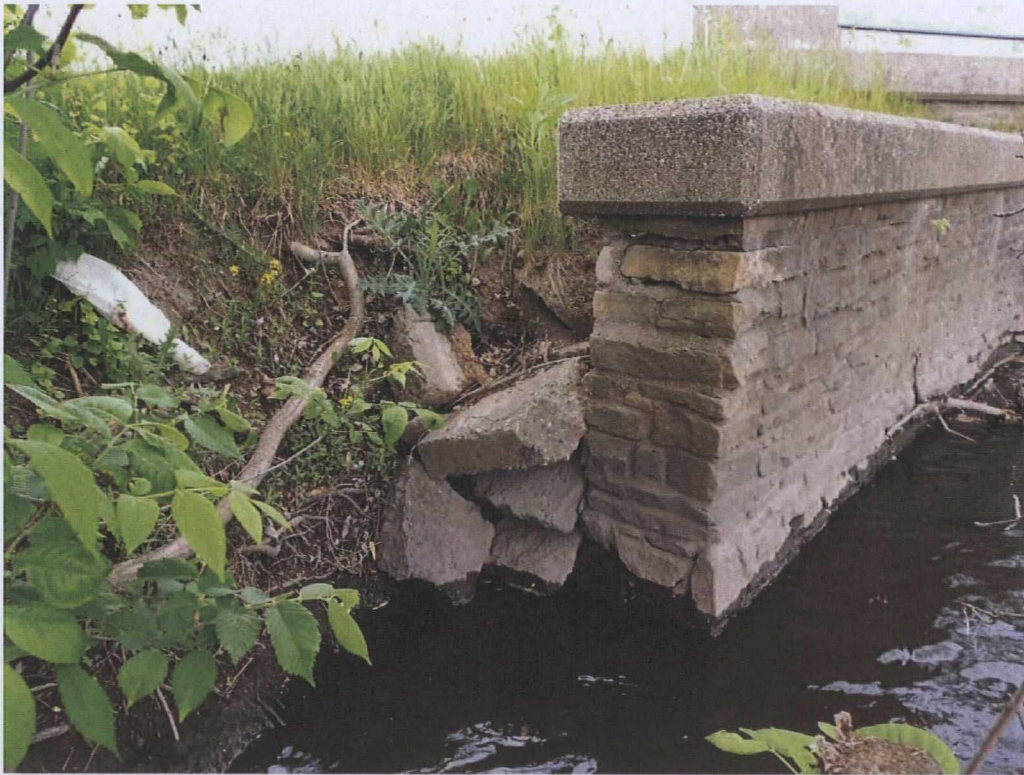
- Moderate erosion was noted behind the southwest wingwall with concrete rubble placed as riprap. Cracking and gaps were noted in the mortar joints.
- There is a significant amount of woody debris caught on the upstream face of the structure. The debris is reducing the flow in the west pipe, causing high velocities and deepened channel in the east pipe.

Bank erosion around southwest wingwall with concrete rubble riprap
